# Reconnaissance study of landslides related to the January 2009 storm in the Acme Watershed

*January 2010*

Washington State Department of  
Natural Resources  
Forest Practices Division  
Olympia, Washington

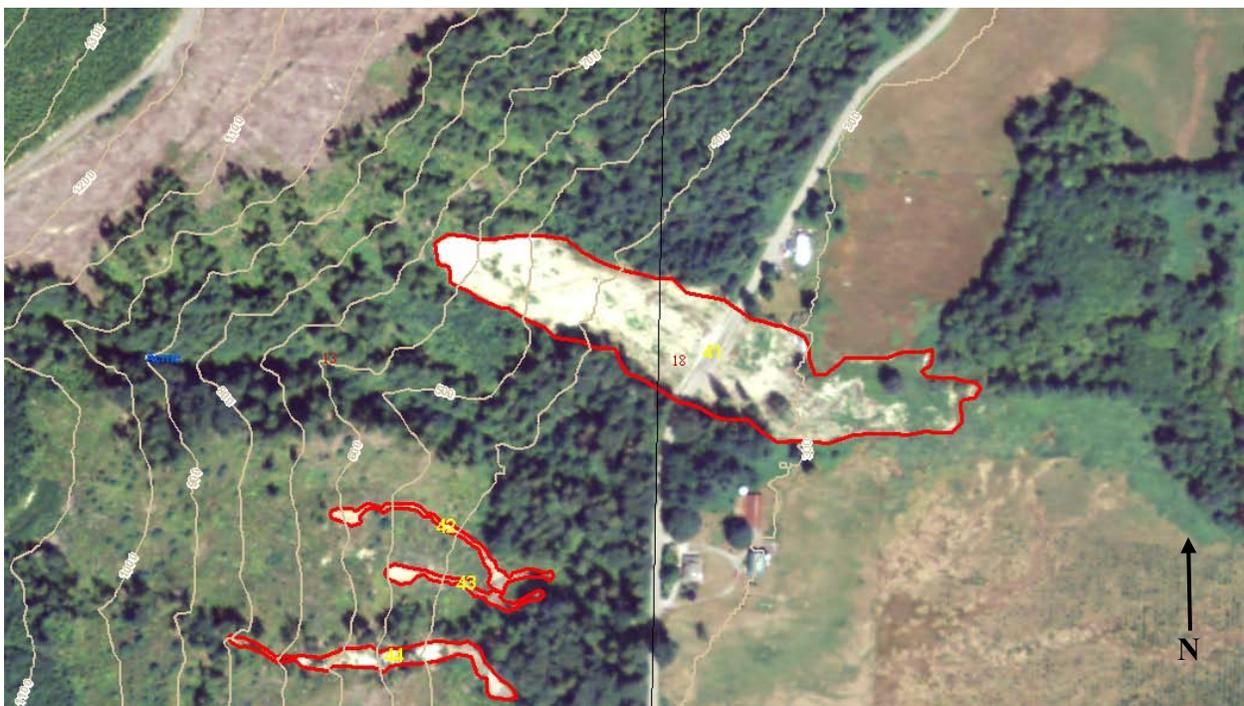
**Figure 4.** Air photo of a debris avalanche north of Sygitowicz Creek. The landslide area is approximately six acres.

Figure 4 shows a typical debris avalanche in the Acme watershed.
